ROF 1 ARDF 2m receiver

ROF 1 – Change note

Date: 11 Nov 2006

Change note upgrade to R3.2

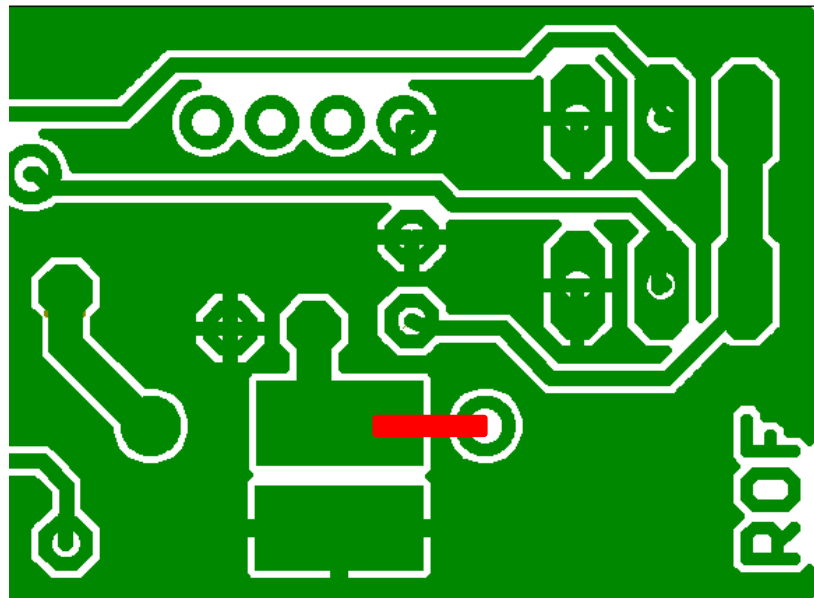
Change note 1

VBAT power not connected from pad to the internal signal.

Connect pad on the solder side of the board to the pin of the D2 pin as shown.
